Pentium[®] Pro Processor Specification Update

Release Date: April 1998

Order Number: 242689-027

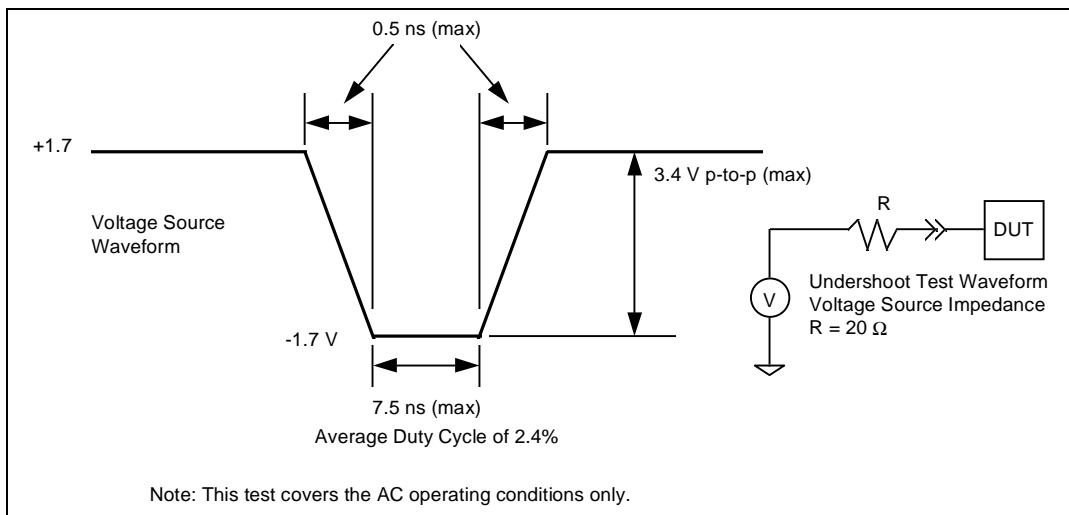
The *Pentium® Pro Family Developer's Manual, Volume 1: Specifications*, Section 11.15., will include the following undershoot specification, to simplify signal integrity issues on signals that can be driven by more than one device simultaneously:

The Pentium Pro processor bus signals AERR#, BERR#, BINIT#, BNR#, HIT#, and HITM# (only) are capable of sinking an 85 mA current pulse at 2.4% average time duty cycle. This is equivalent to -1.7 V applied to a 20Ω source in series with the device pin for 8 ns at 66 MHz with a utilization of 5%.

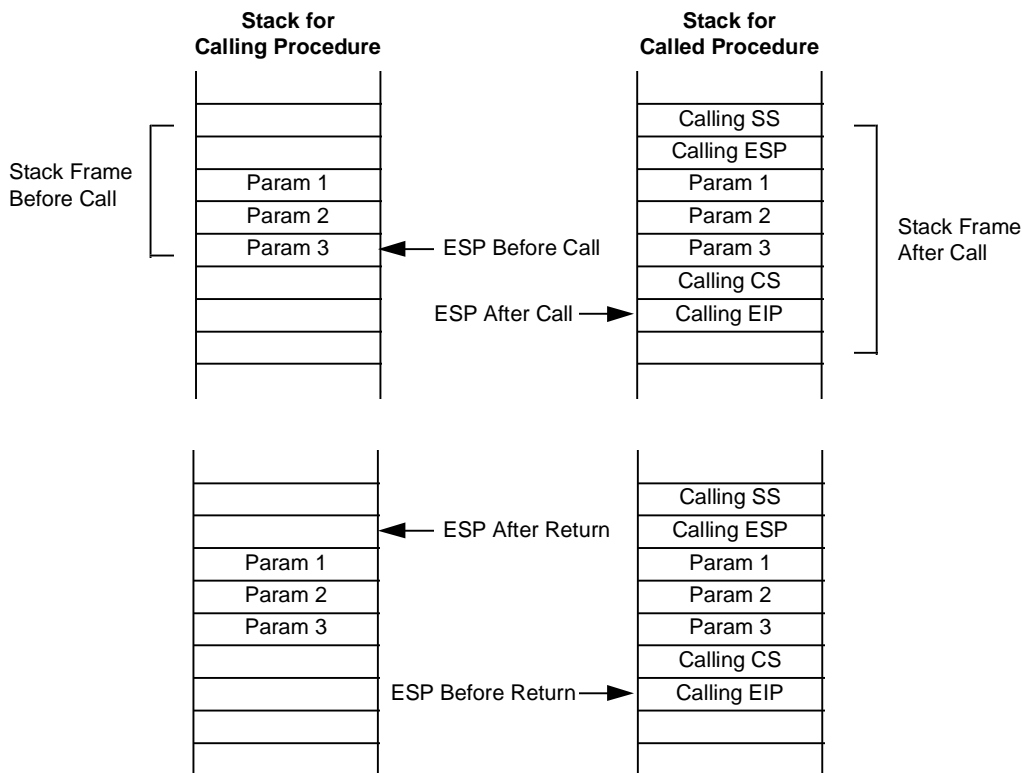
Figure 4-3. Stack Switch on a Call to a Different Privilege Level

When making a call to a more privileged protection level, the processor does the following (see Figure 4-3):

Note: On a return, parameters are released on both stacks if the correct value is given for the *n* operand in the RET *n* instruction.

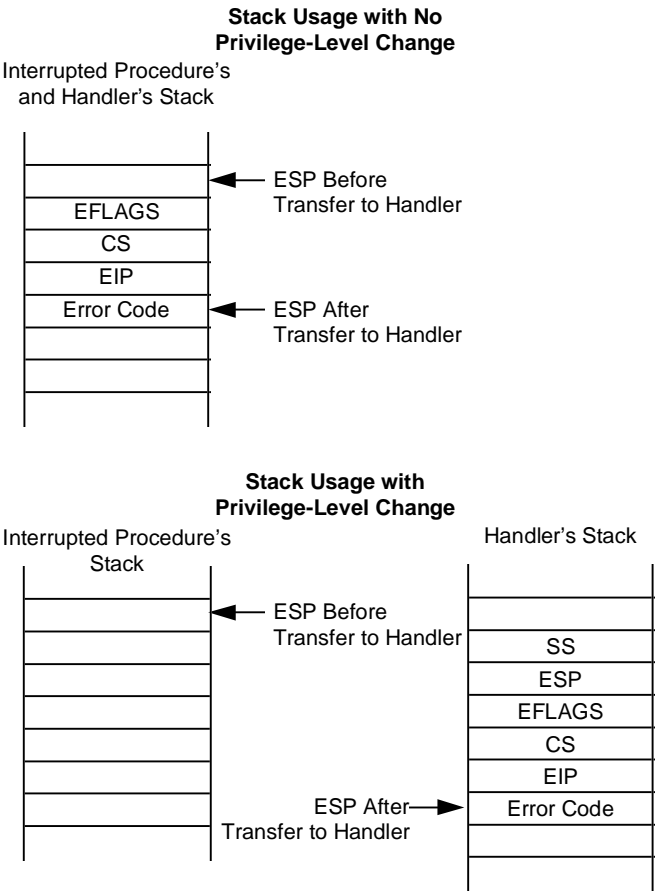
Figure 4-4. Stack Usage on Transfers to Interrupt and Exception Handling Routines

When executing a return from an interrupt or exception handler from a different privilege level than the interrupted procedure, the processor performs these actions:

1. Performs a privilege check.
2. Restores the CS and EIP registers to their values prior to the interrupt or exception.
3. Restores the EFLAGS register.
4. Restores the SS and ESP registers to their values prior to the interrupt or exception, resulting in a stack switch back to the stack of the interrupted procedure.
5. Resumes execution of the interrupted procedure.
